NEA CODAP Project Topical Report

A Review of the “Post-1998”
Experience with Thermal Fatigue
in Heavy Water and Light Water
Reactor Piping Components

**NUCLEAR ENERGY AGENCY
COMMITTEE ON THE SAFETY OF NUCLEAR INSTALLATIONS**

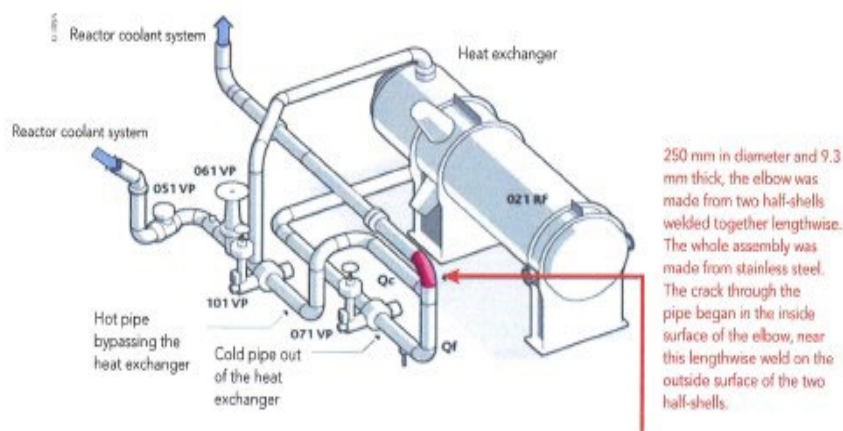
Figure 4.6. Area where the leak occurred

In the 1998 incident at Civaux Nuclear Power Plant, reactor one was undergoing a normal shutdown when a 30 m³/hour leak appeared in the Reactor Heat Removal System (RHRS). This system is used to remove the residual power from the reactor core. This major leak was caused by a 180 mm long crack through the pipe at an elbow immediately below a mixing tee linking a pipe (or line) carrying hot water bypassing the heat exchanger with a pipe carrying cold water coming out of the heat exchanger (Figure 4.6). In the mixing area, the hot water was at a maximum temperature of 180°C and the cold water at a temperature of around 20°C.

From 2000, on IRSN's recommendation, EDF introduced a policy of regularly checking the replaced RHRS sections every 450 hours of operation at wide temperature differences. The 450-hour frequency was based on the first cracks observed in the RHRS circuits removed from reactor 2 at the Civaux power plant. The plant operator's initial analyses could not fully explain the location and extent of the damage observed. Furthermore, the traditional method of analysing (mechanical) fatigue could neither predict nor explain the damage observed. According to the reports on numerous inspections carried out since, TF in the mixing areas of RHRS circuits is a phenomenon that depends on many factors: the operating time at wide temperature differences, thermal and hydraulic factors (the speed and temperature of the fluid), the condition of the surface and the mechanical stresses in the different components. Because there are so many factors, understanding this type of fatigue is particularly complex.

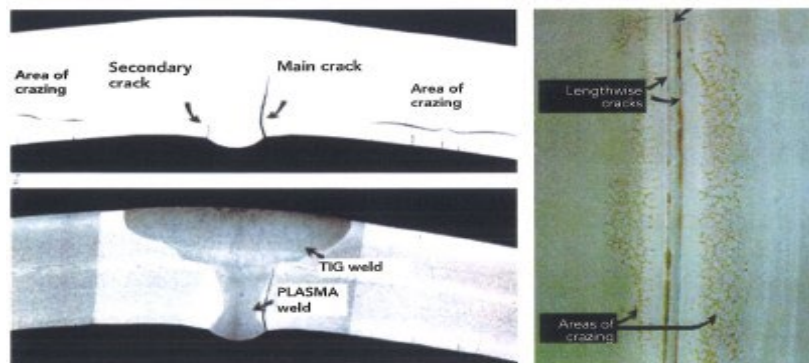
Figure 4.7. Cross-sectional view and internal view of weld bead of the cracked elbow

Inspections were carried out of the other 1 450 MW reactors (Civaux 2, Chooz B1 and B2) and then of all other reactors. The inspections were then extended to all mixing areas in the RHRS circuits of French reactors. The ultrasonic testing revealed damage to all the areas checked, prompting EDF to replace the relevant areas of the RHRS circuits in all reactors within three years. Examinations of the RHRS piping sections that had been removed revealed evidence of TF that had not been taken into account at the design stage. This phenomenon causes multiple shallow cracks, crazing (cracking of the surface) or isolated cracks starting at the base of a weld bead (Figure 4.7).

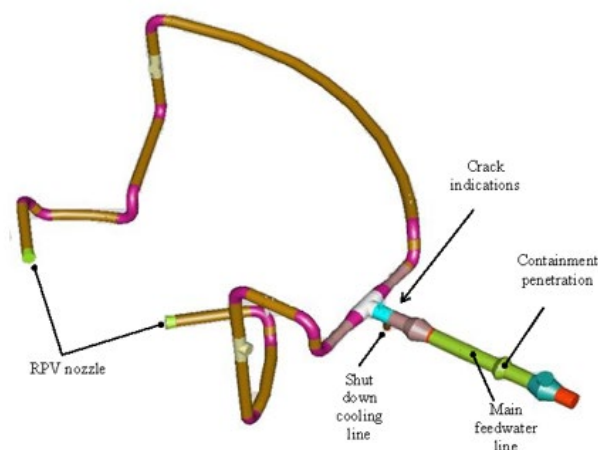
Figure 4.11. Location of the crack indications in FW/RHR mixing tees

An example of recent TF experience in OL1 and OL2 involves the discovery of several 2 to 5 mm deep cracks on the inner surface of the main feed-water piping. The cracks were detected during respective refuelling outages in 2014. These cracks were located in the base metal of the FW/RHR mixing tees. The feed-water system of the AA-IV design consists of two main header pipes, each with a RHR branch connection. The RHR system is basically always in operation. When the reactor is in hot standby, there is no preheating of the feed-water. To keep the RPV water level within the normal allowable range, smaller amounts of cold water are added through one of the FW lines. Thus, the $\sim 20^{\circ}\text{C}$ feed-water and 280°C RHR water mix and create cyclic temperature fluctuations in the large-diameter FW pipe upstream the tee (Figure 4.11).

Cracks in the mixing tees in OL1 and OL2 were first discovered in the early 1980s and in response to these discoveries the mixing tees in both units were replaced in 1986. To minimise thermal fluctuations and in response to this operating experience, the original

design of the mixing tee was improved by installing sparges (or static mixers) to improve the mixing of the fluids and to create a more uniform temperature distribution.⁹

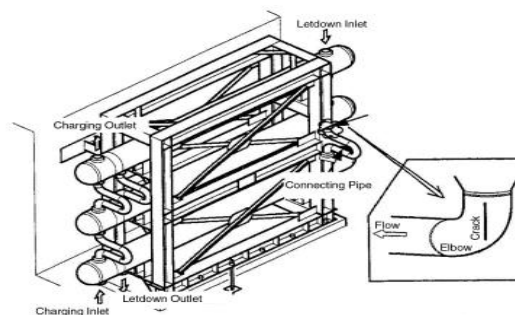
Figure 4.16. Location of primary coolant leakage

- Tsuruga-2 (4-loop PWR), July 1999. A primary coolant leak was detected at 6.05 am when fire alarms in the passage outside SG compartments C and D were activated. At the same time, another alarm showed a high level in the containment sump followed by an increase in charging flow and an increase in the reading of the containment vessel particulate radiation monitor. A controlled shutdown was started at 6.24 am. When cold shutdown conditions had been reached, radiation levels inside containment began to fall. Engineers entered containment at 18.45 and found a leak at the outlet of one of the regenerative heat exchangers of the CVCS. The leak was stopped by closing an isolation valve and upon removal of insulation from the pipework a through-wall crack was found on an elbow joint (Figure 4.16).

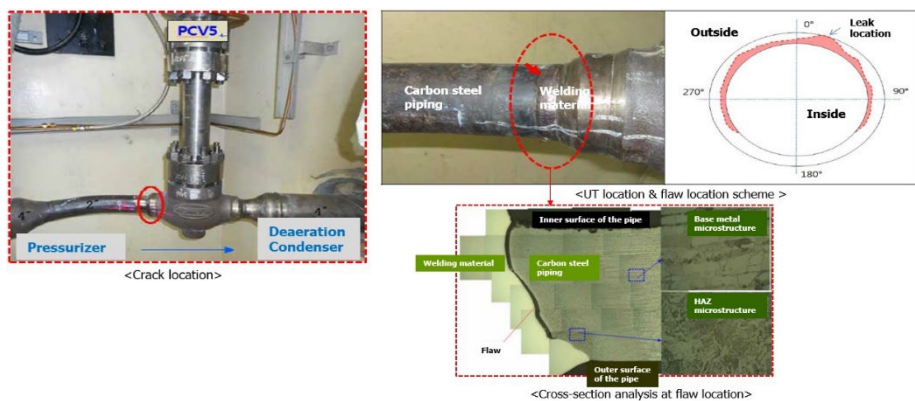
Figure 4.18. Fracture surface analysis results

The fracture surface and cross-section analysis showed that the flaw morphology was a typical corrosion-fatigue crack (Figure 4.18). The key damage mechanism was determined to be circumferential CFC, which grew from the inside to outside surface of the welded connection along the boundary between the base and welding metals due to extended exposure to a corrosive environment coupled with the repeated thermal loading from operation of the valve as well as the tensile stress caused by the interference with some of the pipe hanger.

The evaluation of the leak rate from the fine through-wall crack showed that the leaked coolant (about 0.9 kg) was properly recovered as the plant proactively sealed the potential leak points when the increasing trend of the reactor building tritium concentration was noticed. Since there were no meaningful changes in terms of radioactivity level including the tritium concentration in reactor building and the amount of effluent release from the vent, it was concluded that the leakage from the through-wall crack on the welded

connection of the pressuriser steam bleed valve did not cause any safety concerns such as radiological leakage to the environment.
