NEA/CSNI/R(2005)5/VOL1

**NUCLEAR ENERGY AGENCY  
COMMITTEE ON THE SAFETY OF NUCLEAR INSTALLATIONS**

**INTERNATIONAL STANDARD PROBLEM NO. 48  
CONTAINMENT CAPACITY**

**Synthesis Report**

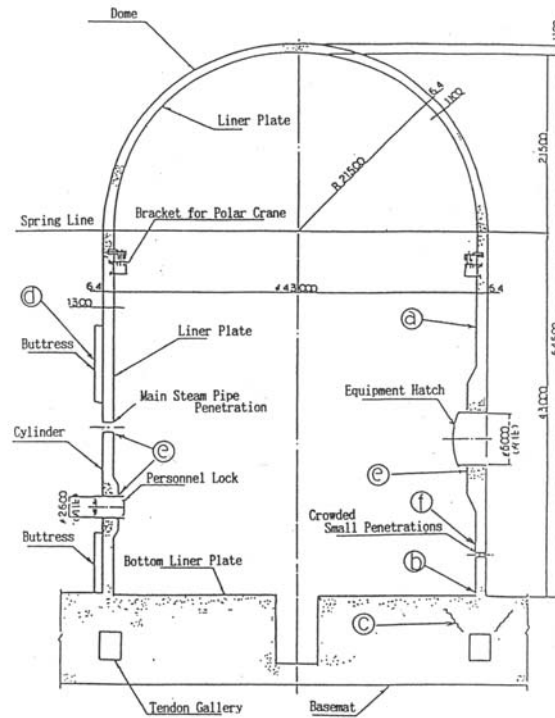
**Figure 2.3 Elevation of PCCV Prototype and Potential Failure Locations**

The general arrangement of the prototype and representative failure mode locations are shown in Figure 2.3.

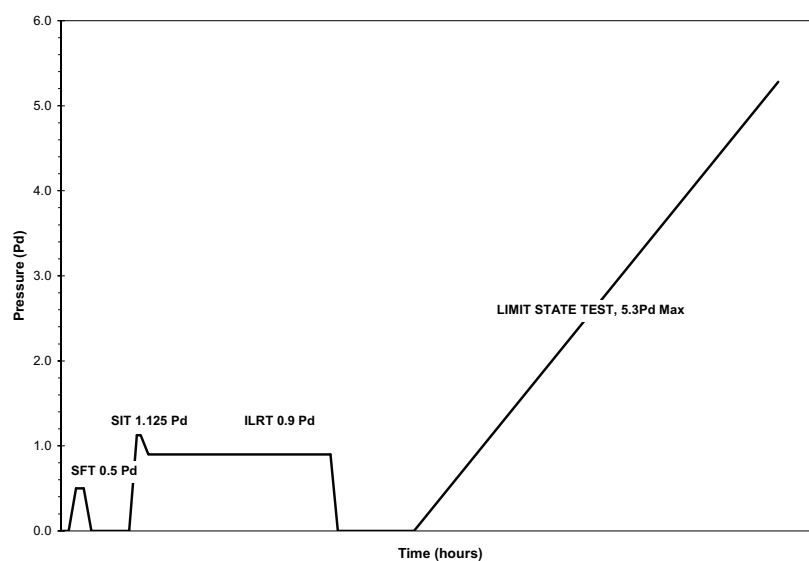
**Figure 3.1 Pressurization Plan**

- A leak check and System Functionality Test (SFT) @ 0.5 Pd (2.0 kgf/cm<sup>2</sup> or 28.4 psig)
- A Structural Integrity Test (SIT) @1.125 Pd followed by an Integrated Leak Rate Test (ILRT) @ 0.9 Pd
- A Limit State Test (LST) to the static pressure capacity of the PCCV model (or the pressurization system, whichever comes first)

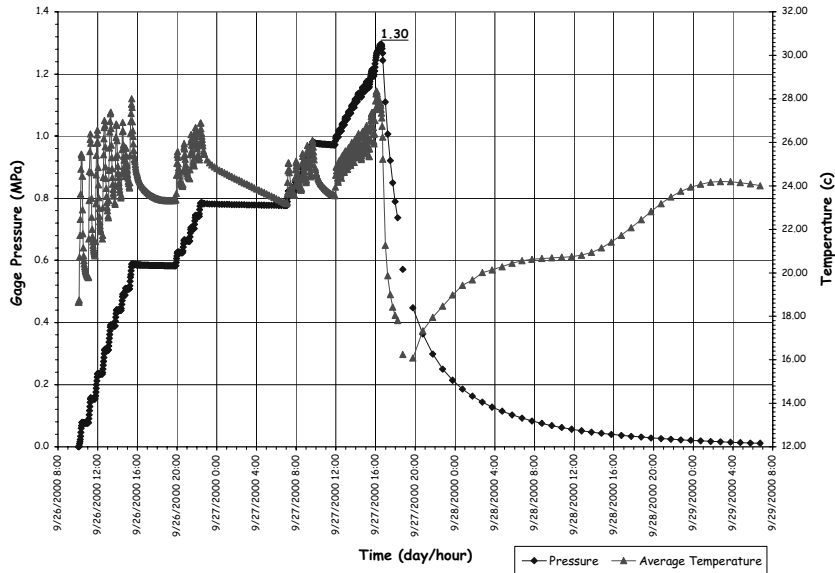
Figure 3.2 Limit State Test Pressure and Average Temperature

The pressure and average temperature time histories during the LST, including depressurization, are plotted in Figure 3.2. The LST followed the planned pressurization sequence up to the point where the model began leaking.

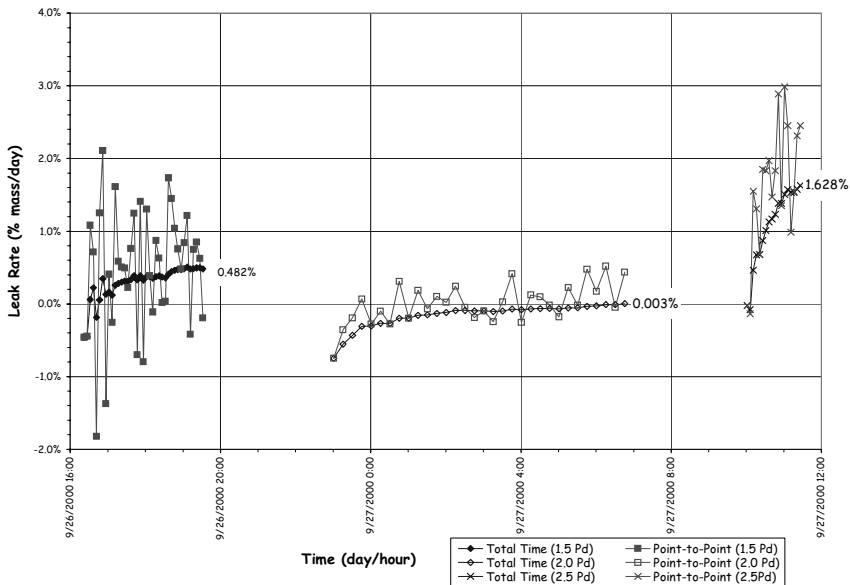
Figure 3.3 LST Calculated Leak Rates at 1.5, 2.0 and 2.5 Pd

leak rate of 1.628% mass per day was calculated. The leak rate calculations at 1.5, 2.0 and 2.5Pd are plotted in Figure 3.3. Coupled with the confirmation from the AO that the acoustic data continued to confirm that some new event had occurred, it became clear that the model was leaking, most likely from a tear in the liner in the vicinity of the E/H. Plots of the output of the four internal acoustic sensors surrounding the E/H at 2.3, 2.4 and 2.5 Pd are shown in Figure 3.4.

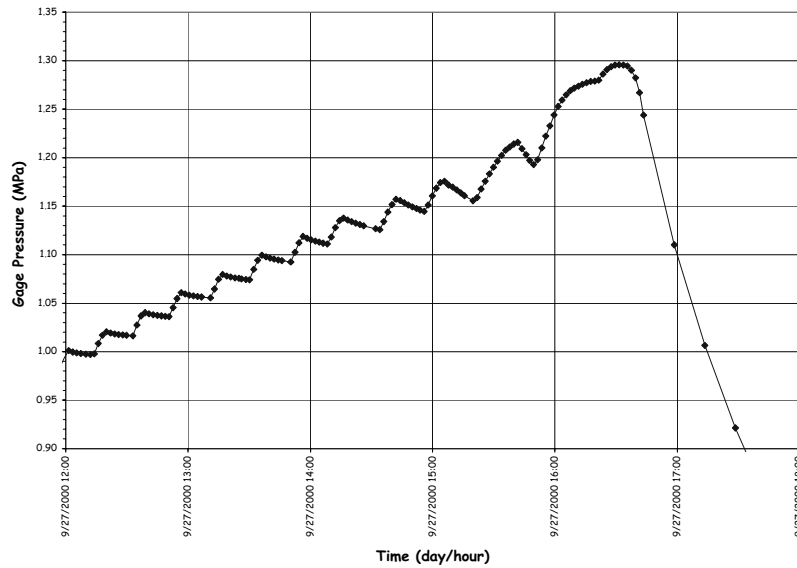
**Figure 3.5 LST Pressure Time History, 2.5 to 3.3 Pd**

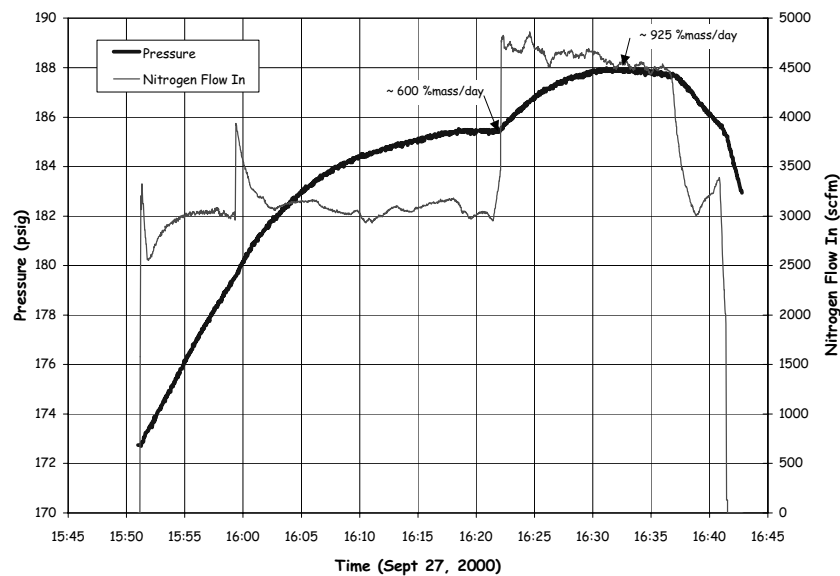
**Figure 3.6 LST Pressure and Flow Rates @ Maximum Pressure**

The nitrogen flow rate was increased to the maximum capacity of the pressurization system, 142 std.m<sup>3</sup>/min (5000 scfm), and the pressure was increased to slightly over 3.3 Pd before the leak rate exceeded the capacity of the pressurization system. The pressure time history and flow rates during the final phase of the test are shown in Figures 3.5 and 3.6. Since it was no longer possible to increase the pressure in the model and the supply of nitrogen was nearly exhausted, the TC made the decision to begin terminating the test.

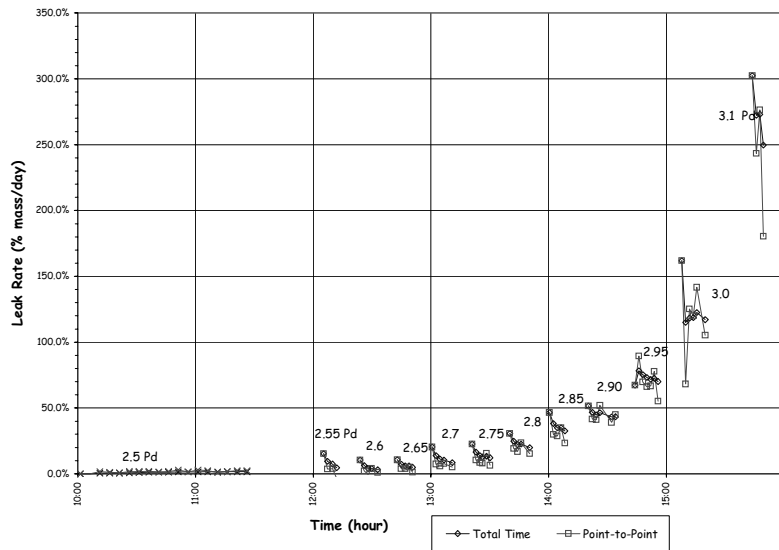
Figure 3.7 LST - Estimated Leak Rates (2.5-3.1 Pd)

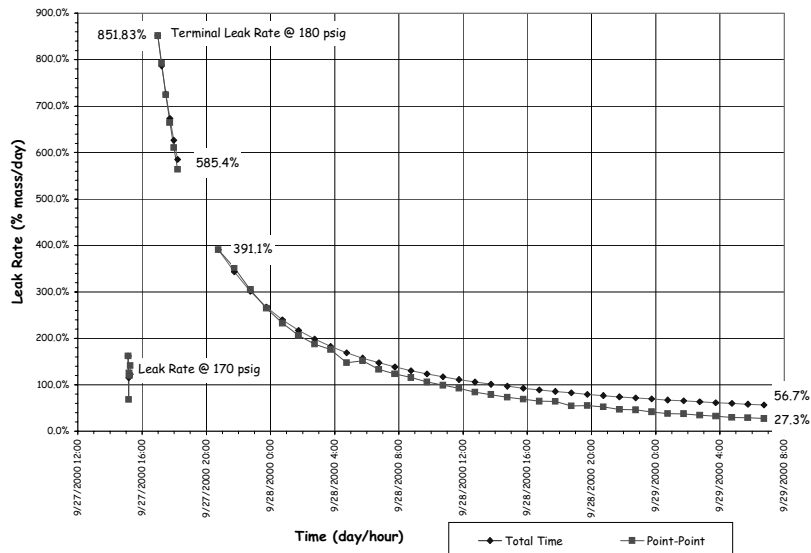
Figure 3.8 LST Estimated Terminal Leak Rates

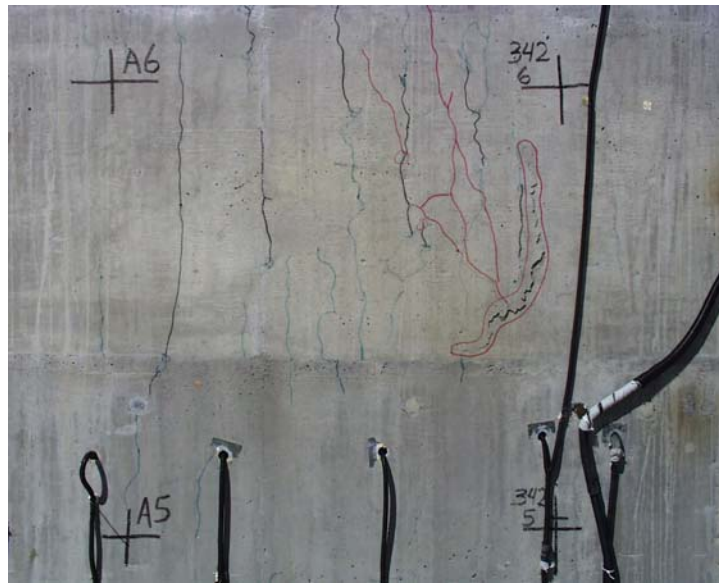
**Figure 3.9 Post-LST Cracks @ Az. 350°, El 4680 to 6200 (Grid 45)**

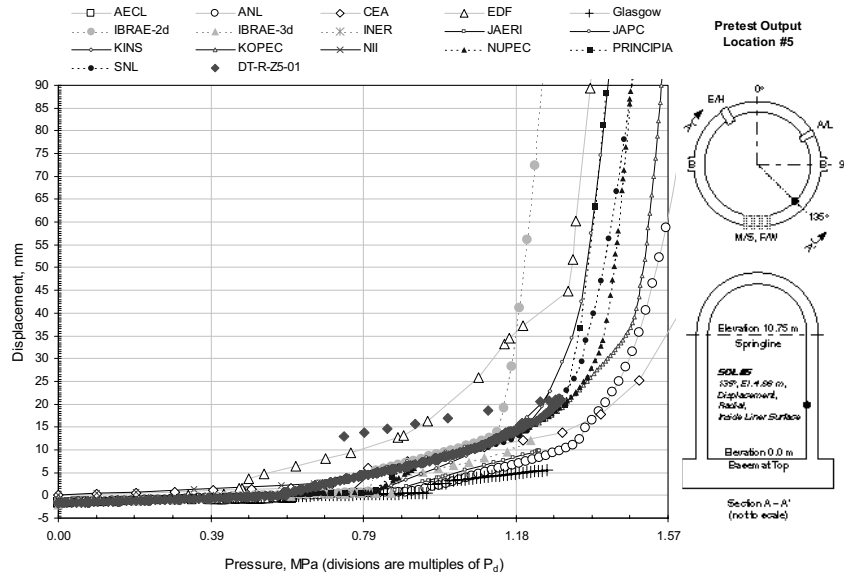
**Figure 3.10 LST Radial Displacement @ Az. 135°, El. 4680**

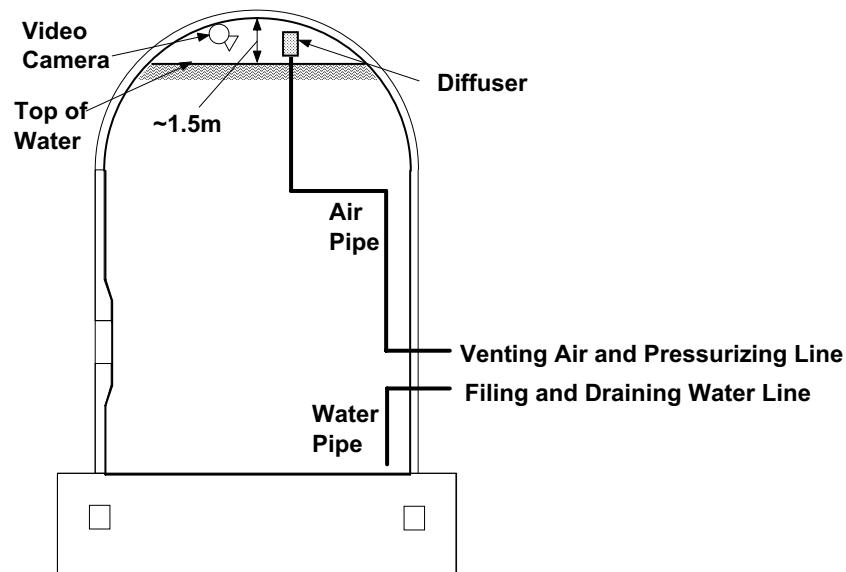
**Figure 3.11 PCCV Structural Failure Mode Test Concept**

- Since the pressurization system could compensate for small leaks, it was not essential that the elastomeric liner be completely leak tight, only that the leaks were small enough to allow the model to be pressurized to the desired level.
- Leaks of water would be readily visible compared to gas leaks.
- In the event of a catastrophic rupture of the PCCV model, the energy stored in the model nearly filled with water was much less than the stored energy if pressurized to the same level with only gas. As a result, the safety exclusion zone around the model could be reduced if necessary.

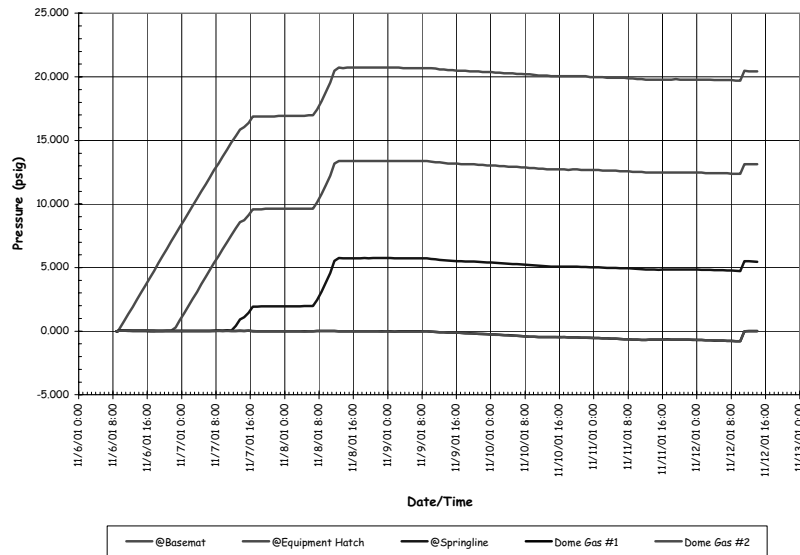
**Figure 3.13 Pre-SFMT Hydrostatic Pressures**

leaking was not significant. The pressure time histories at various elevations in the model from the start of filling up to the SFMT are shown in Figure 3.13. This figure illustrates the hydrostatic head and also reflects the slight loss of water due to leaks. The water level was ‘topped off’ on November 12, prior to the start of the SFMT.

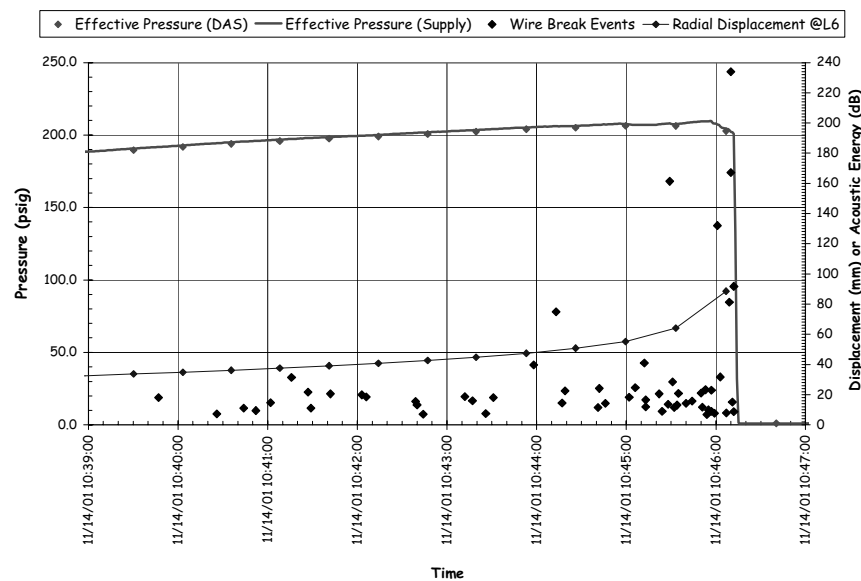
Figure 3.15 SFMT Wire Break Events vs. Pressure vs. Displacement

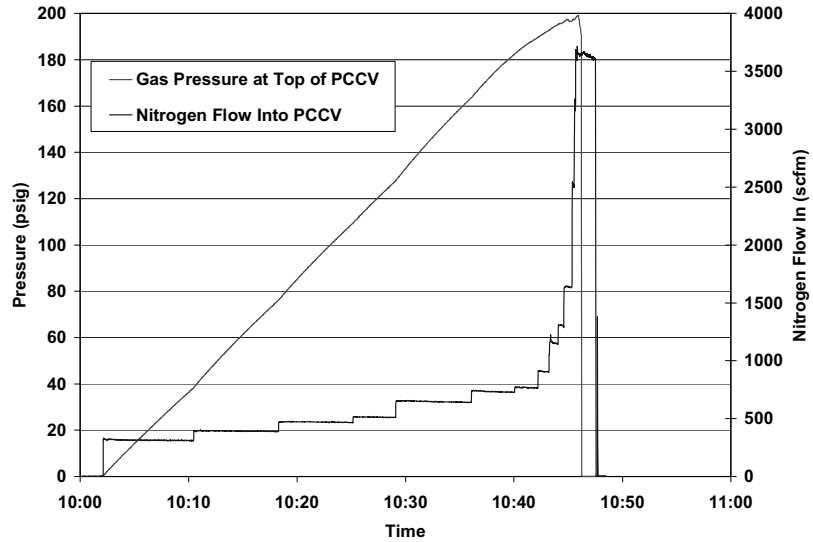
Figure 3.16 SFMT Pressurization System Data

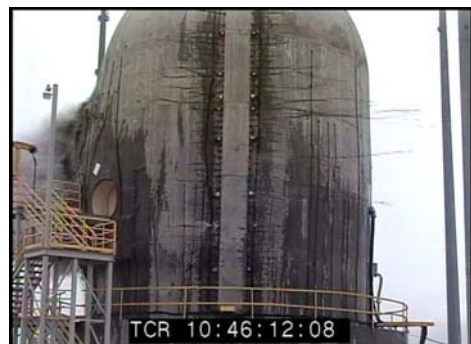
(b) 270° Azimuth

Figure 3.17 SFMT: Rupture of the PCCV Model

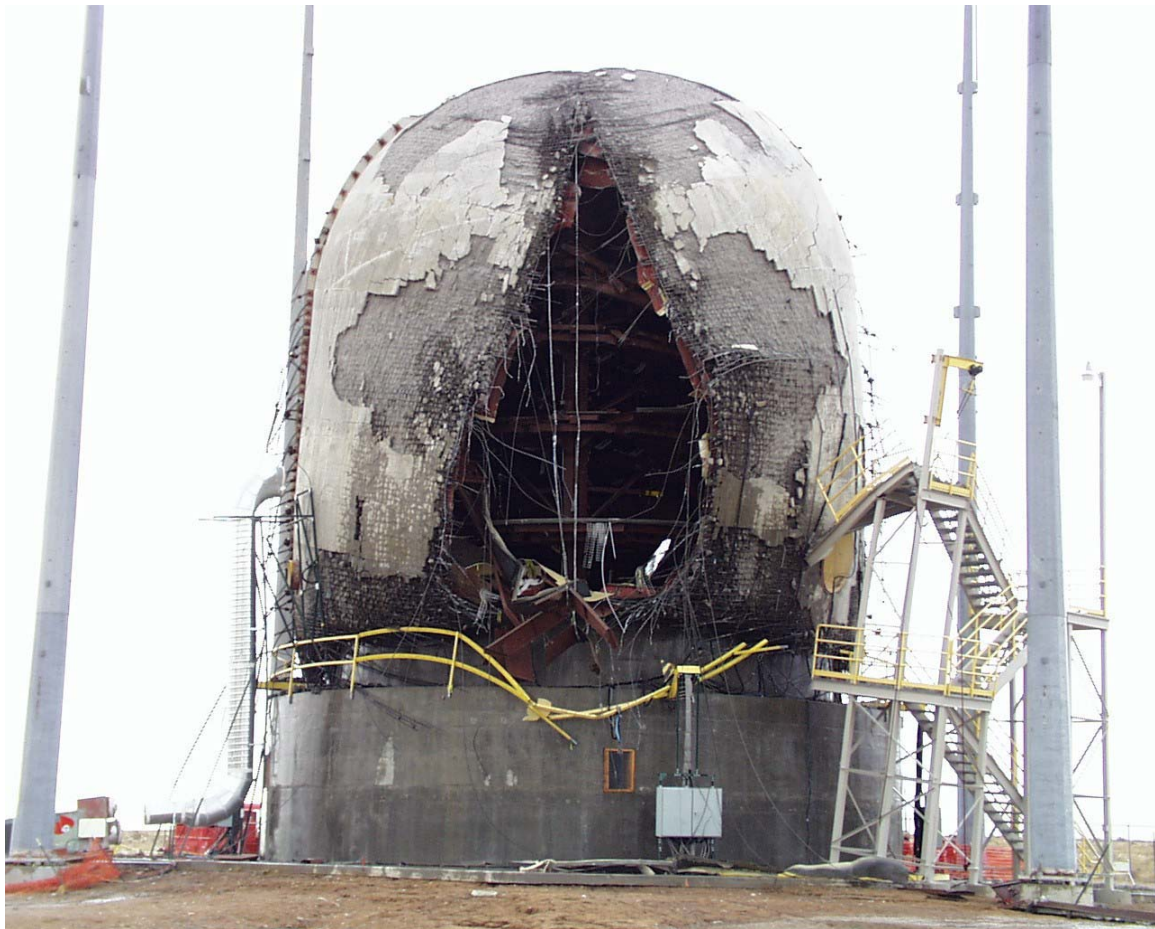
**Figure 3.18 PCCV Model after the Structural Failure Mode Test**

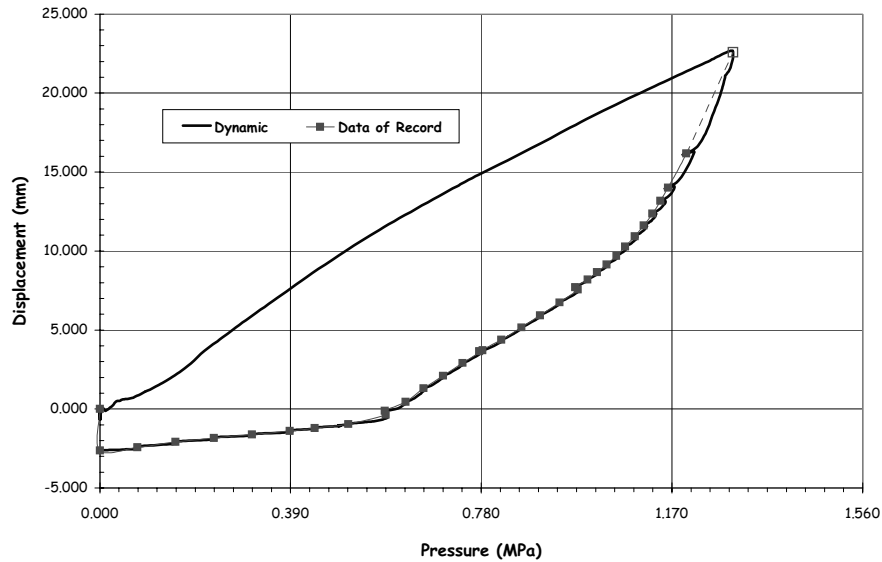
**Figure 3.19 Radial Displacement @ AZ 135°, El. 6200**

the drift due to model creep and/or leakage is apparent. Furthermore, the DOR data set does not capture the maximum pressure. In subsequent discussions of the DOR, the response at the maximum pressure from the DYNAMIC data has been appended to the DOR for completeness

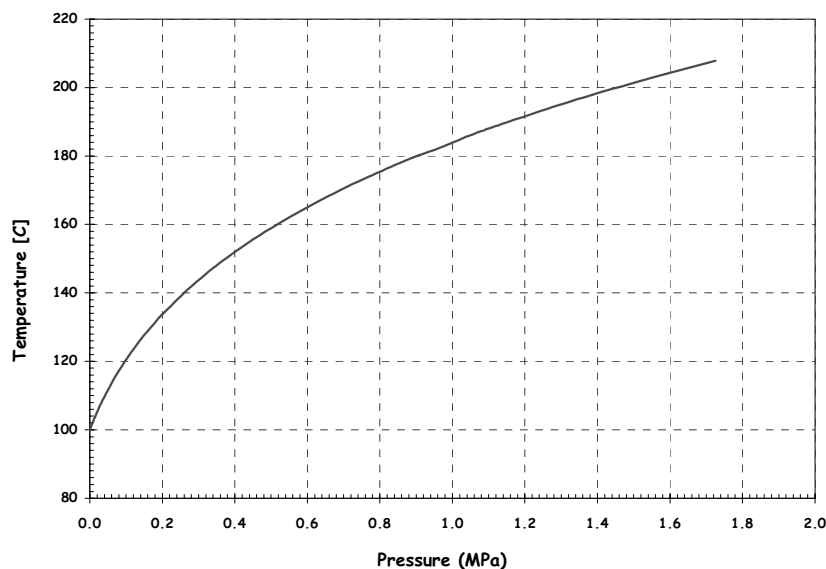
**Figure 5.1 Case 1 Saturated Steam Conditions**

Saturated steam conditions were chosen for Case 1 since most analytical and experimental evaluations of containment capacity utilize this as an assumed bound on the combined effects of temperature and pressure. The saturated steam conditions for Case 1 are defined by standard steam tables, illustrated graphically in Figure 5.1.

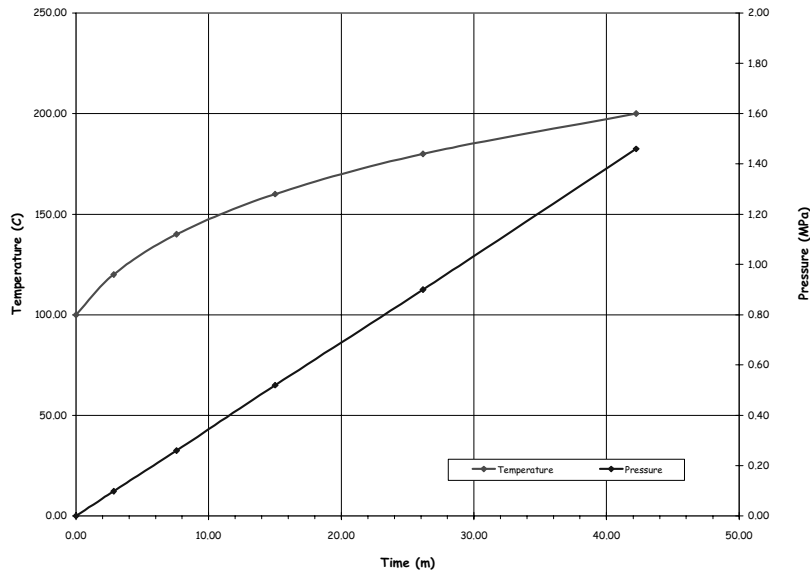
**Figure 5.2 Case 1 Pseudo-Time Histories**

For purposes of the response calculations, a pseudo-pressure/temperature time history was assumed to coincide with pressurization rate utilized during the SFMT, approximately 5 psi/min. These time histories are shown in Figure 5.2

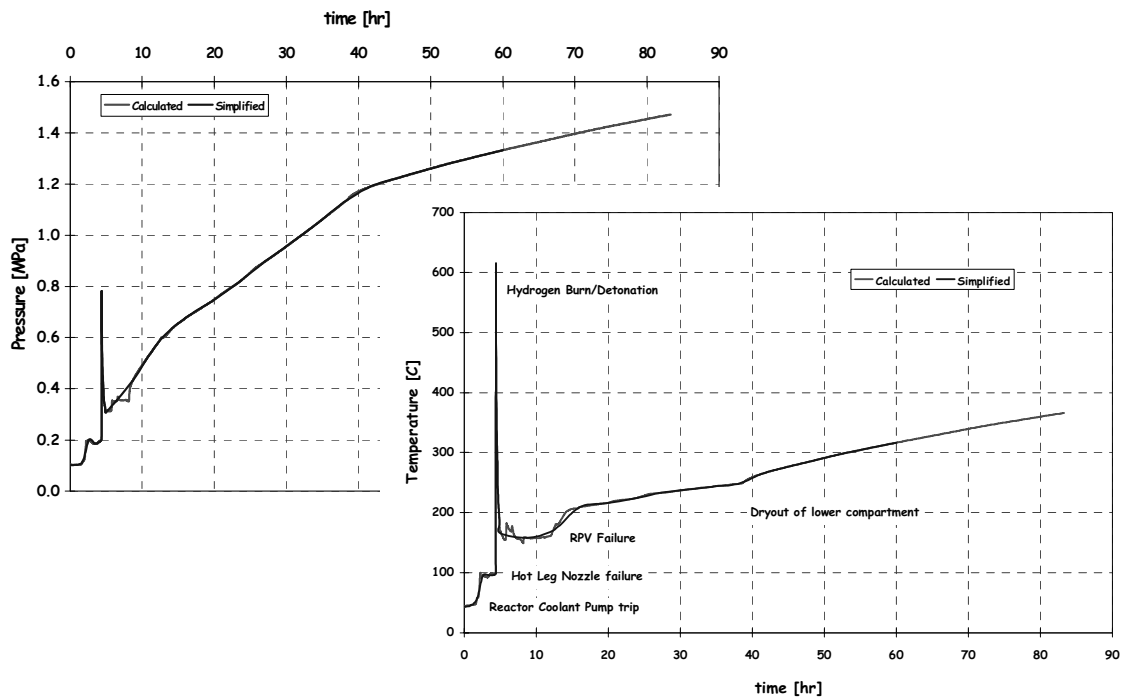
**Figure 5.3 Case 2 Station Blackout Pressure and Temperature Time Histories**

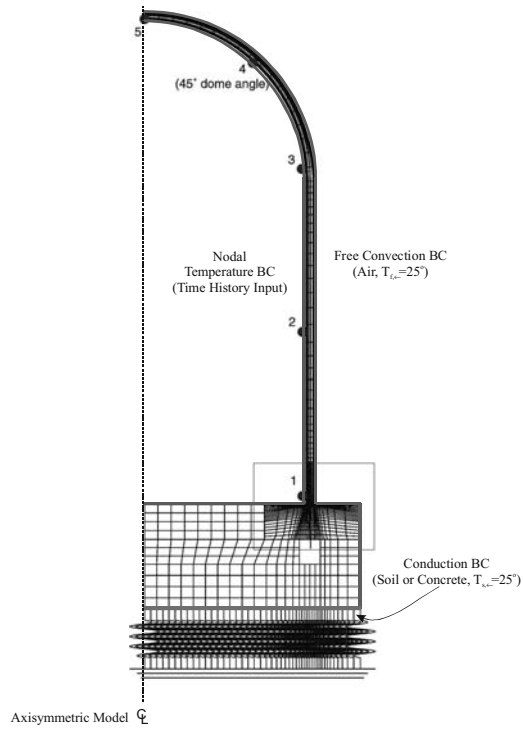
Figure 5.4 Axisymmetric Model with Thermal Boundary Conditions

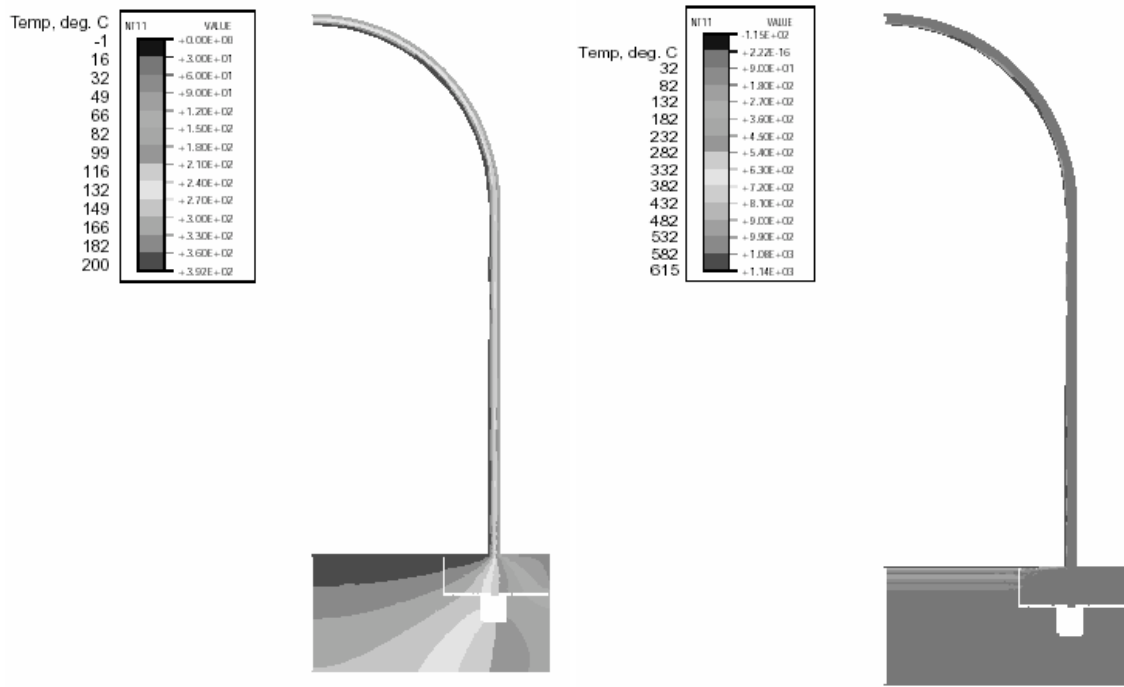
Case 1 Thermal Gradients @ T = 200°C

Figure 5.5 Axisymmetric Model Thermal Gradients

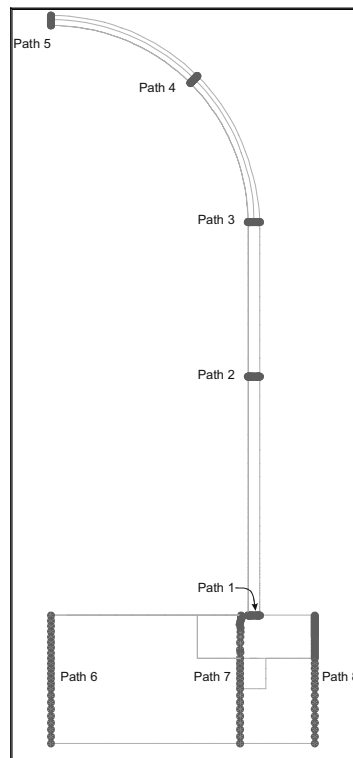
**Figure 5.6 Thermal Gradient Locations**

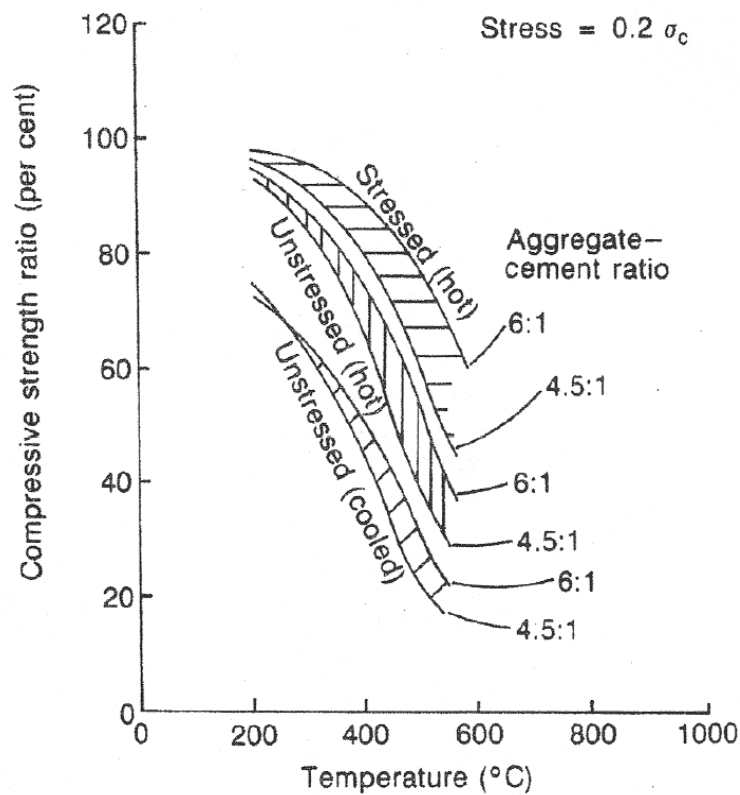
Figure 5.7 Compression Strength Ratio vs. Temp. (Ref. 5)

A sampling of the degradation curves found in the literature review are shown in Figures 5.7 through 5.12. Figure 5.7 shows the trends for three basic kinds of tests found in the literature: “Unstressed” meaning that an unloaded specimen is heated and then loaded to failure while hot; “stressed” meaning the specimen is loaded to some initial stress and then heated; “unstressed residual” meaning that an unloaded specimen is heated and then cooled slowly, then loaded cool to failure. Figure 5.8 shows some additional results comparing aggregate types, all for the “unstressed” condition. Figure 5.9 shows a variety of data from Reference 8, and Figures 5.10 and 5.11 show data for Young’s Modulus from References 8 and 9.

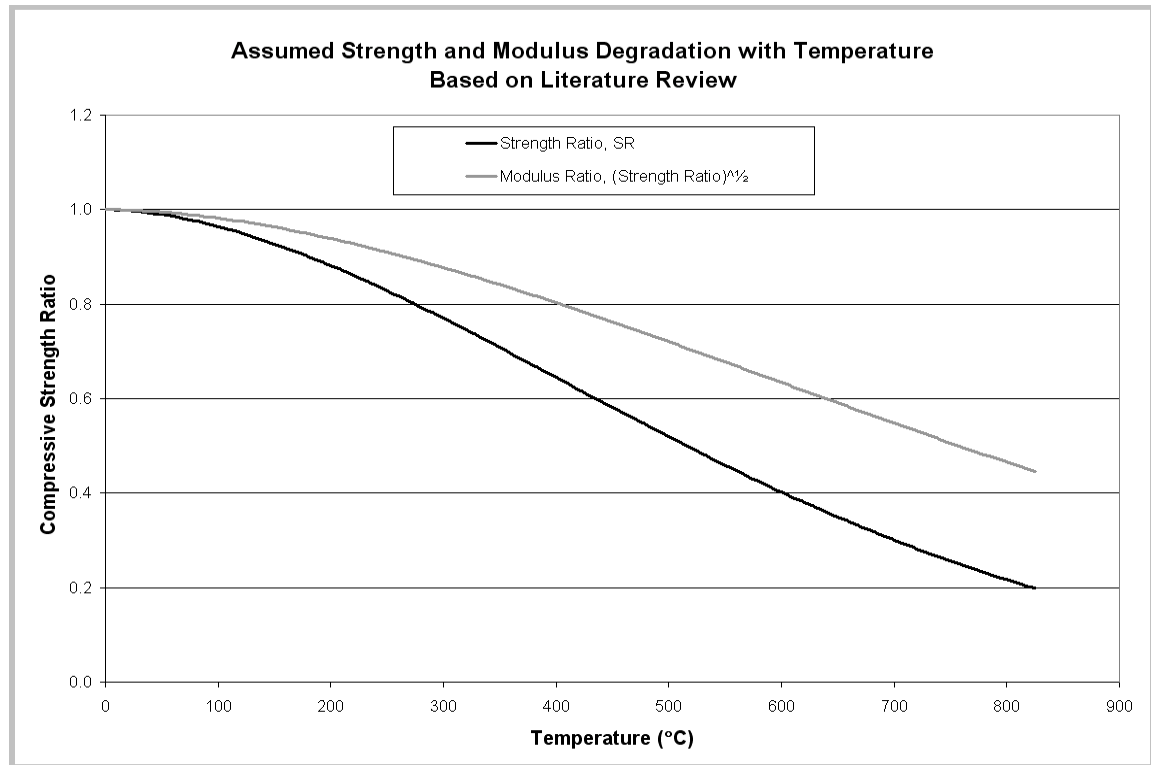
**Figure 5.13 Concrete Compression Strength Ratio vs. Temperature**

It should be noted, however, that the peak strain at which the concrete compressive strength limit is reached also shifts with increasing temperature. While at 25C, this strain is approximately 0.002, it can reach two to three times this value at high temperatures.

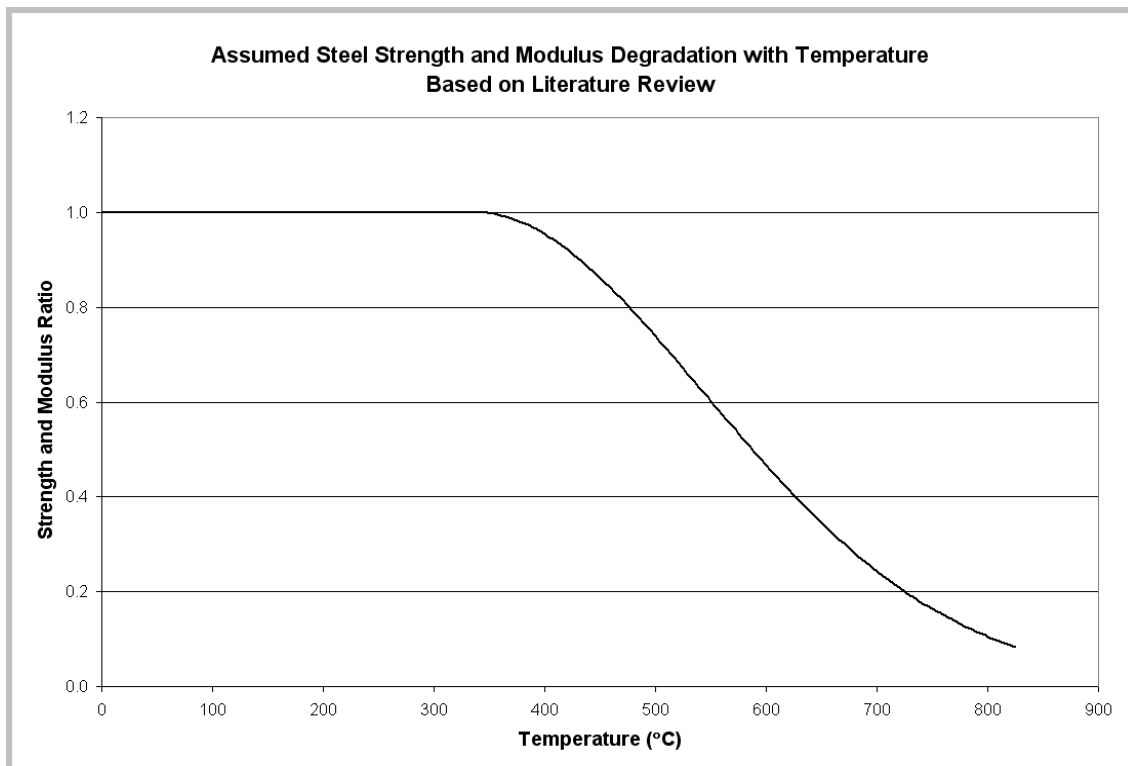
**Figure 5.14 Steel Yield Strength and Modulus Ratio vs. Temperature**

For steel, the Young's Modulus tends to follow the yield strength one-to-one, rather than the square-root relationship found in concrete. The steel yield strength reduction is shown in Figure 5.14.
