NEA CODAP Project Topical Report

A Review of the “Post-1998”
Experience with Thermal Fatigue
in Heavy Water and Light Water
Reactor Piping Components

**NUCLEAR ENERGY AGENCY
COMMITTEE ON THE SAFETY OF NUCLEAR INSTALLATIONS**

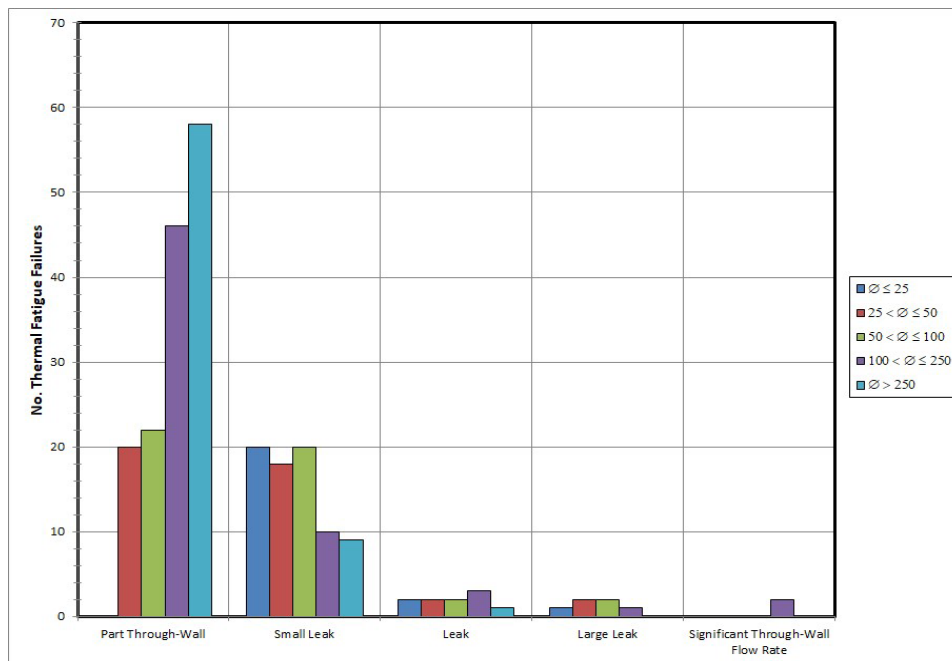
Figure 4.4. TF failures by structural integrity impact

Note: The two events with “significant through-wall flow rate” are Civaux-1 (May 1998, ca. 8.3 kg/s peak flow rate) and Olkiluoto-1 (August 1979, ca. 20 kg/s peak flow rate).

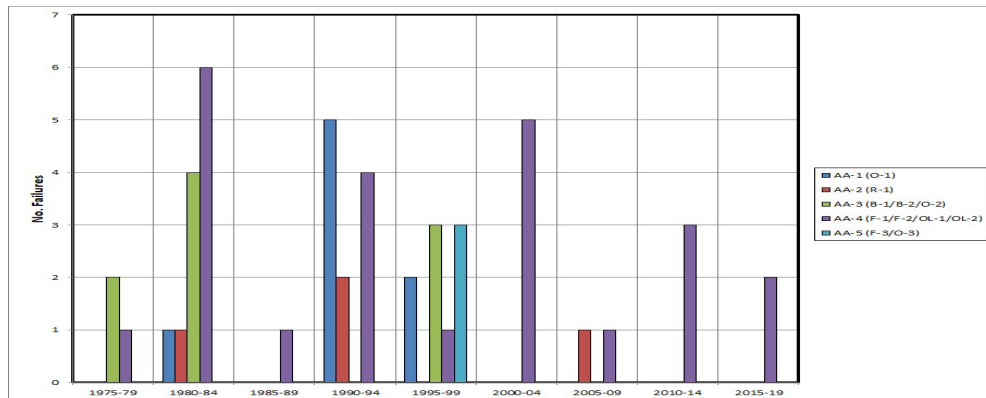
Figure 4.10. TF failures in AA reactors

An example of recent TF experience in OL1 and OL2 involves the discovery of several 2 to 5 mm deep cracks on the inner surface of the main feed-water piping. The cracks were detected during respective refuelling outages in 2014. These cracks were located in the base metal of the FW/RHR mixing tees. The feed-water system of the AA-IV design consists of two main header pipes, each with a RHR branch connection. The RHR system is basically always in operation. When the reactor is in hot standby, there is no preheating of the feed-water. To keep the RPV water level within the normal allowable range, smaller amounts of cold water are added through one of the FW lines. Thus, the $\sim 20^{\circ}\text{C}$ feed-water and 280°C RHR water mix and create cyclic temperature fluctuations in the large-diameter FW pipe upstream the tee (Figure 4.11).

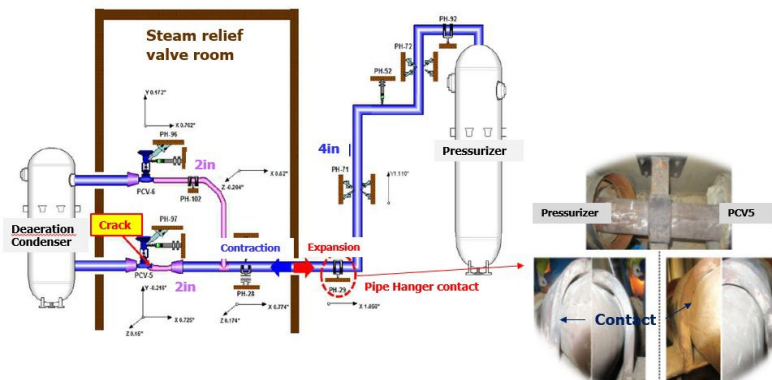
Figure 4.17. Pressuriser steam relief valve schematic diagram

During a planned outage at Wolsong unit 4, a through-wall flaw was found on a welded connection of the pressuriser steam bleed valve. On 17 June 2014, at around 10:30am, while the unit was on guaranteed shut down for a planned maintenance outage, a fine through-wall crack was found at the pressuriser side of the welded connection of the pressuriser steam bleed valve (63332-PCV5); see Figure 4.17. The field investigation

revealed that the pipe was locked in because a pipe hanger (PH-29) had not been installed correctly as designed and the operation of the pressuriser steam bleed valve (63332-PCV5) generated repeated thermal loading to the restrained pipe, which caused corrosion-fatigue cracking (CFC) on the weld zone and ultimately through-wall leakage.

The fracture surface and cross-section analysis showed that the flaw morphology was a typical corrosion-fatigue crack (Figure 4.18). The key damage mechanism was determined to be circumferential CFC, which grew from the inside to outside surface of the welded connection along the boundary between the base and welding metals due to extended exposure to a corrosive environment coupled with the repeated thermal loading from operation of the valve as well as the tensile stress caused by the interference with some of the pipe hanger.

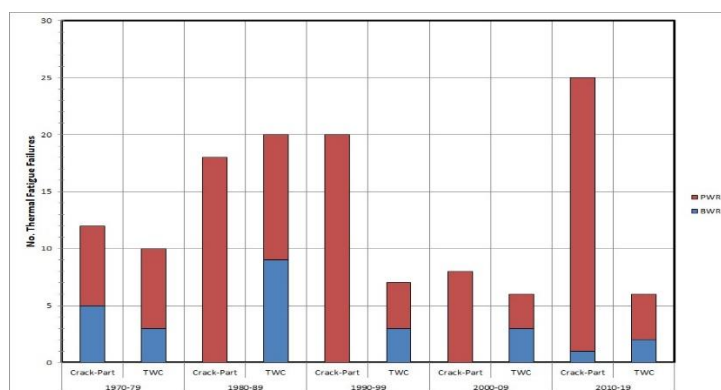
Figure 4.25. The US TF operating experience

The US operating experience with TF is summarised in Figure 4.25. Thermal stratification was first identified in 1977 as the root cause for ASME III Code Class 2 feed-water nozzle cracks which occurred at a number of PWR plants. The next industry-wide thermal stratification concern arose at Farley unit 2 in late 1987, because of an unisolable primary system water leak. Subsequently, reports from foreign reactors (e.g. Tihange unit 1 and Genkai unit 1) described similar events. Table 4.3 summarises the NRC regulatory bulletins and information notices related to thermal stratification. References [11] [29] and [30] provide more detailed technical information on TF experience for the period from 1970 to 2000.
